## Navigation Conditions at Lock and Dam 19, Mississippi River

**Hydraulic Model Investigation**

Final report

Navigation conditions at Lock and Dam 19, Mississippi River: hydraulic model investigation / by Howard Park; prepared for U.S. Army Engineer District, Rock Island.

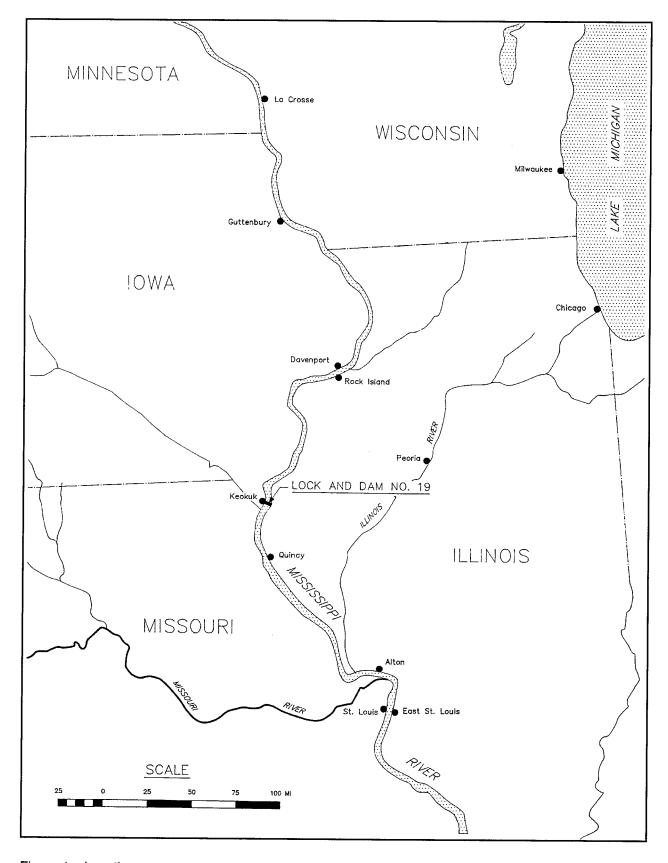
Figure 1. Location map

Lock and Dam No. 19 is located on the right descending bank of the Mississippi River approximately 364.3 river miles¹ above the mouth of the Ohio River at Keokuk, Iowa (Figure 1). The normal operating pool at Lock and Dam No. 19 is at elevation (el) 518.2 and extends 46.2 miles up the Mississippi River to Lock and Dam No. 18. The principal existing structures are a 110-ft by 1,200-ft-long lock, a closure dam that connects the 1,200-ft lock to the powerhouse, the Union Electric Powerhouse with 16 power generating units, a gated dam, consisting of 119 gate bays with crest elevation of 507.2, that extends from the Union Electric Powerhouse to the left bank, and a radial ice fender that extends upstream of the dam about 1,300 ft.

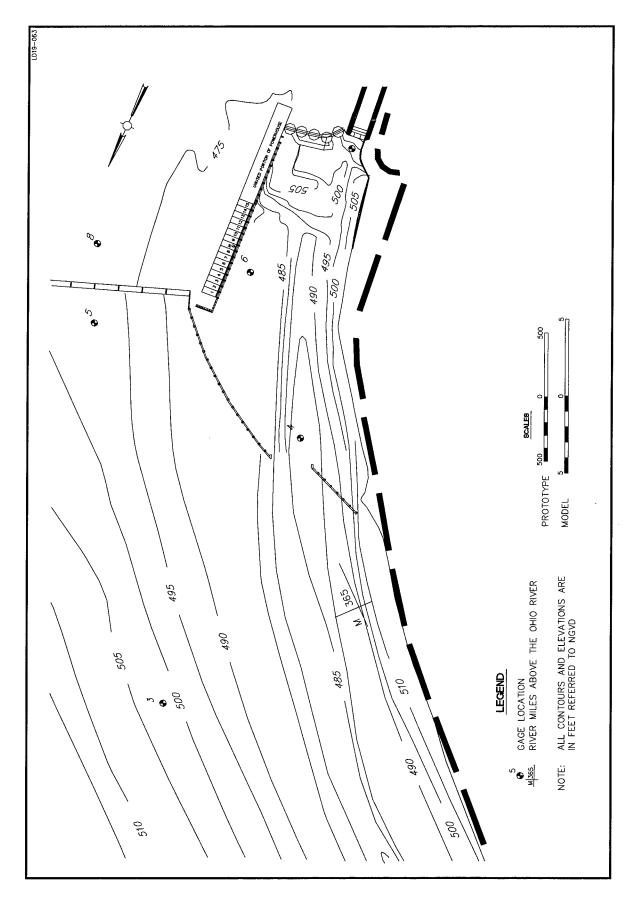
Figure 4. Pre-existing conditions

Pre-existing conditions, as shown in Figure 4, are the same as the base test with one exception: a ported ice fender some 525 ft long extending into the river channel from the right descending bank.

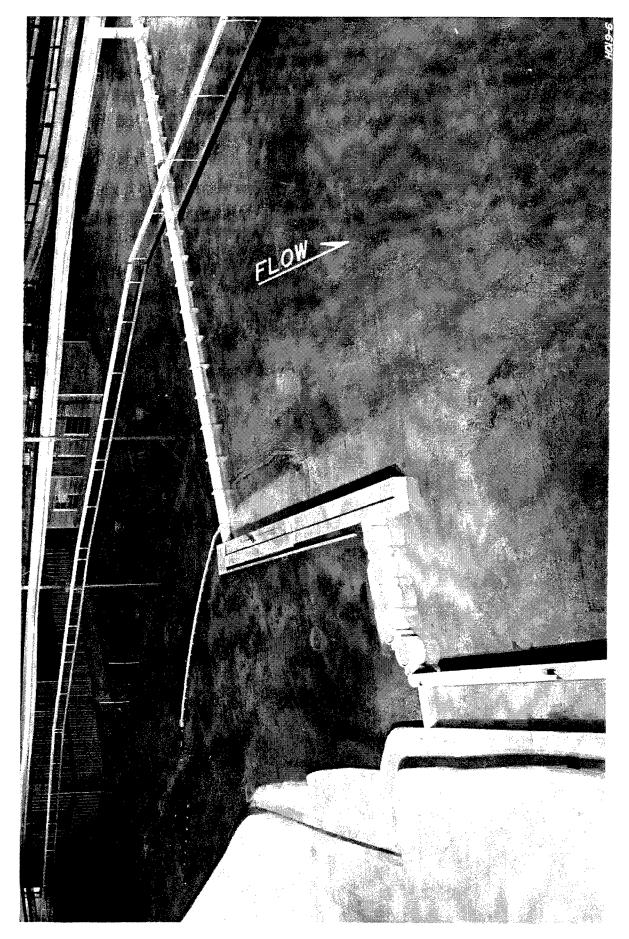
Photo 1. Base Test, looking upstream, showing the approach and forebay to the lock

Base tests, as shown in Figures 2 and 3 and Photo 1, were conducted with the model reproducing existing conditions. These tests verified that the model reproduced prototype conditions and provided information and data that could evaluate the effects of the proposed alternatives on current direction and velocities, water-surface elevations, and navigation conditions. Existing conditions consisted of the following principal features:

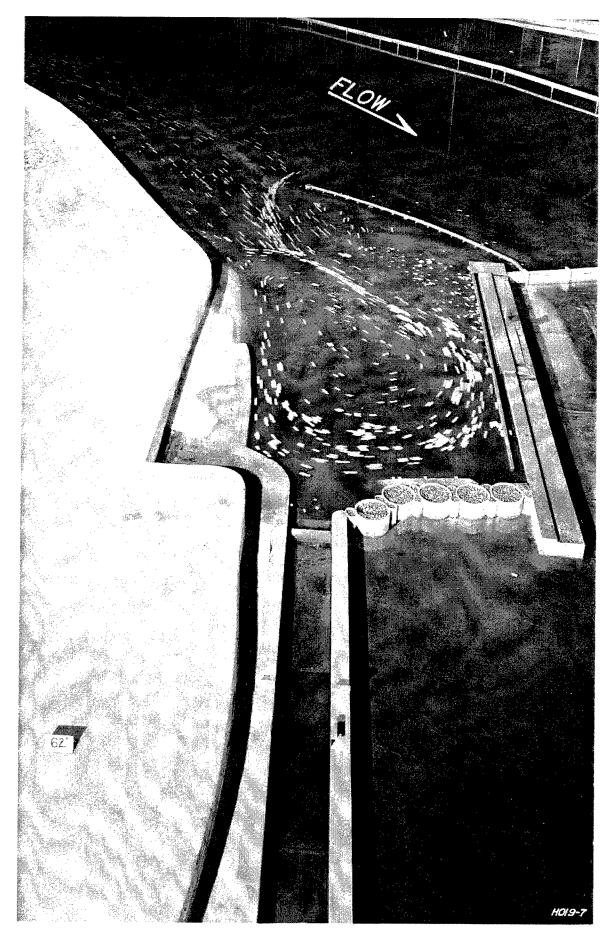
Base Test, total riverflow = 62,000 cfs, powerhouse discharge = 62,000 cfs. Looking upstream, confetti showing surface current patterns Photo 2.

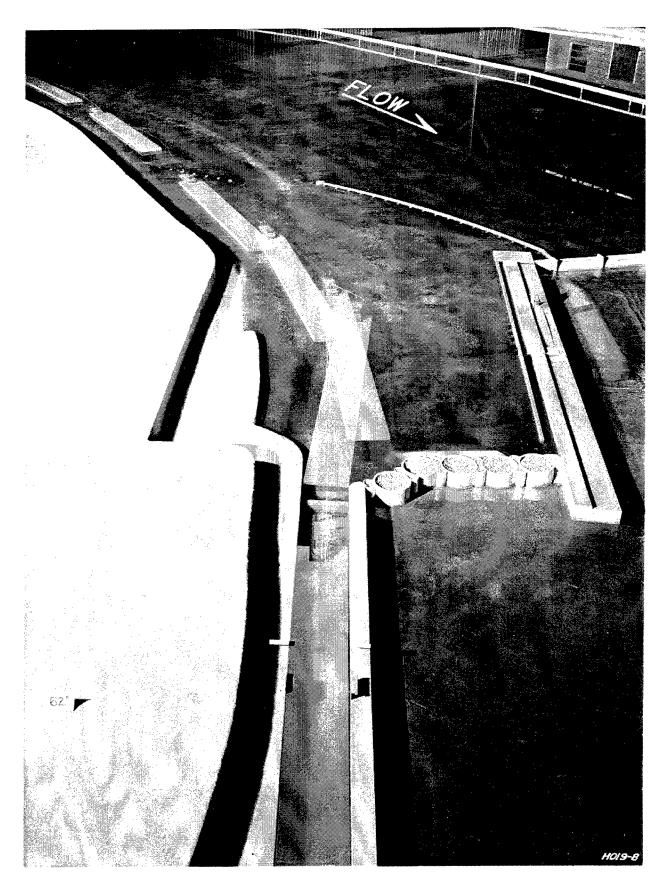
Photo 3. Base Test, total riverflow = 62,000 cfs, powerhouse discharge = 62,000 cfs. Looking upstream, showing the path of downbound tow approaching and entering the lock (note maneuvering required to enter lock)

**Navigation conditions.** The model test, conducted with a 105-ft-wide by 975-ft-long barge flotilla with a 150-ft pusher, indicated that navigation conditions for downbound tows were very difficult and would require a considerable amount of maneuvering for tows to enter the lock due to the current alignment in the lock approach with all flows tested. With the 62,000-cfs and 122,000-cfs riverflows, downbound tows approaching close along the right descending bank and maintaining proper alignment could align with and enter the lock with a minimum amount of maneuvering (Photos 3 and 4). However, if the tow moves away from the right bank and intercepts the currents moving across the lock approach toward the powerhouse, the tow could lose control and be pushed into the powerhouse (Photo 5). With the 249,000-cfs riverflow, considerable maneuvering and possibly some type of assistance would be required for downbound tows to align with and enter the lock chamber (Photo 6). There was a strong tendency for the tow to be moved into the powerhouse. If tows maintained control, then navigation conditions for upbound tows leaving the lock were satisfactory with all flows tested (Photos 7 - 9).

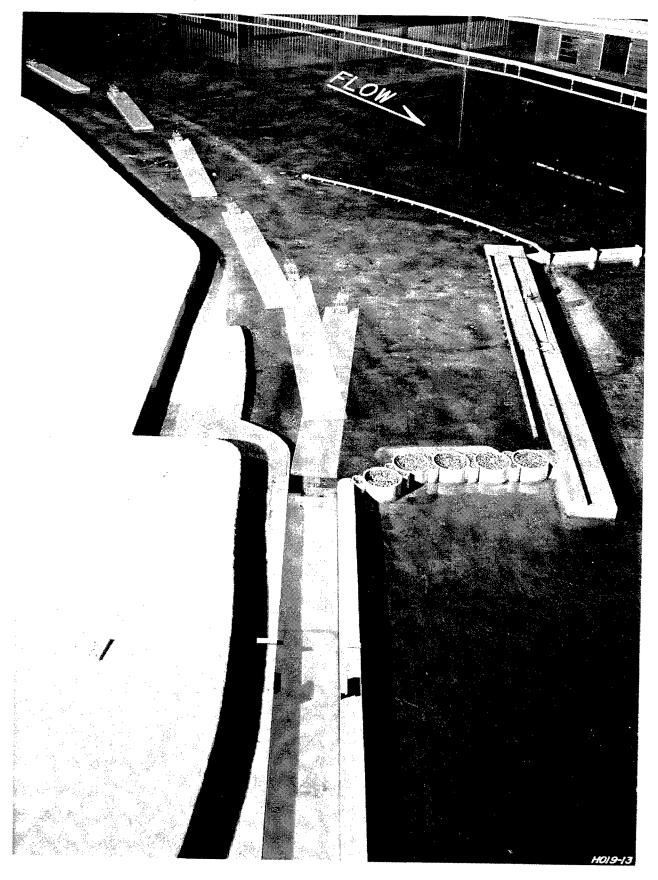
Photo 4. Base Test, total riverflow = 122,000 cfs, powerhouse discharge = 62,000 cfs. Looking upstream, showing the path of downbound tow approaching and entering the lock (note maneuvering required to enter lock)

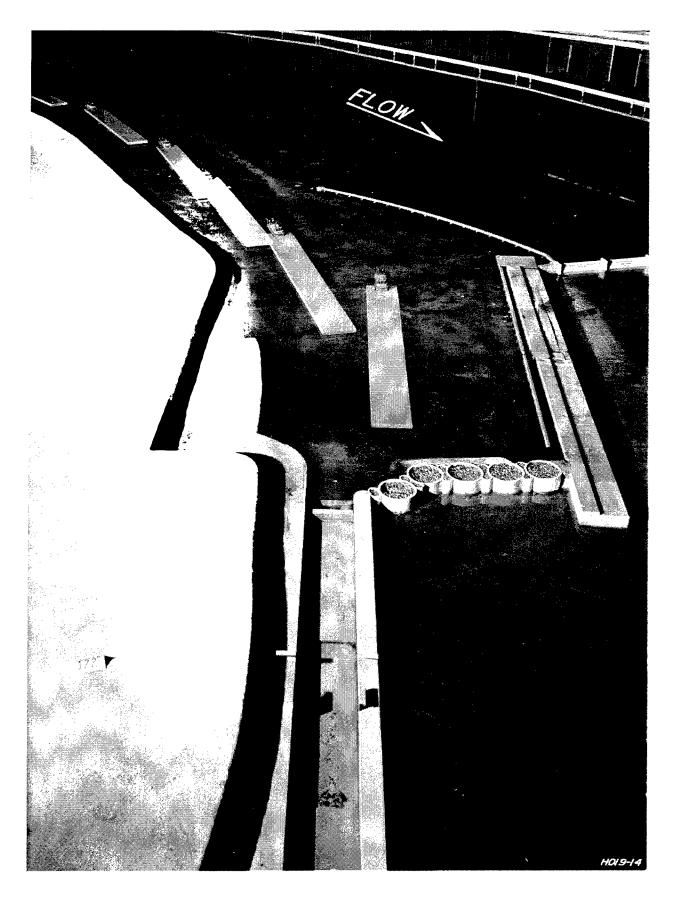
Photo 5. Base Test, total riverflow = 122,000 cfs, powerhouse discharge = 62,000 cfs. Looking upstream, showing the path of downbound tow approaching lock (note tendency for currents to move tow toward powerhouse)

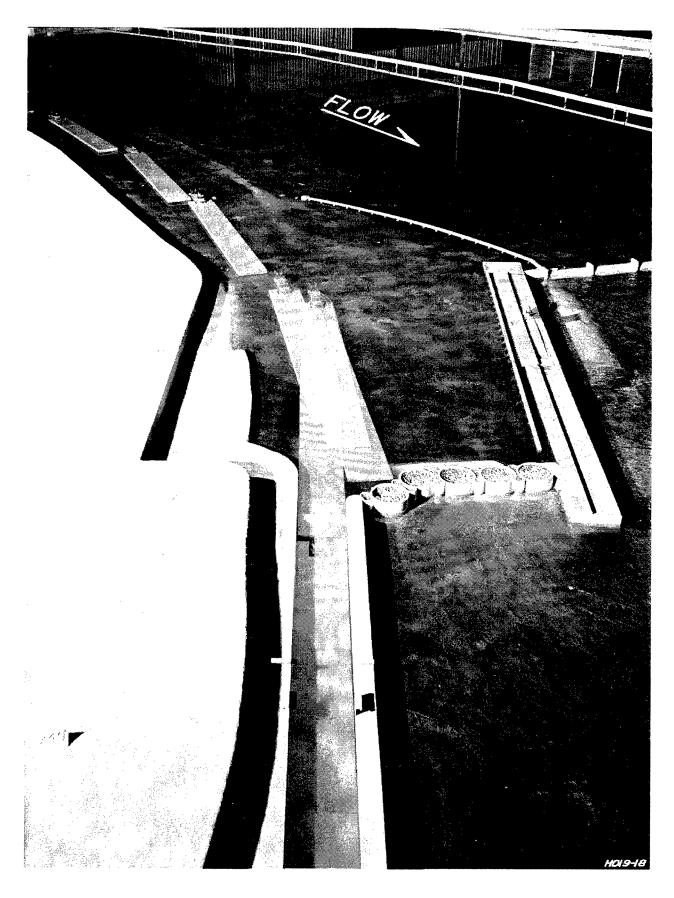
Photo 6. Base Test, total riverflow = 249,000 cfs, powerhouse discharge = 62,000 cfs. Looking upstream, showing the path of downbound tow approaching and entering the lock (note maneuvering required to enter lock)

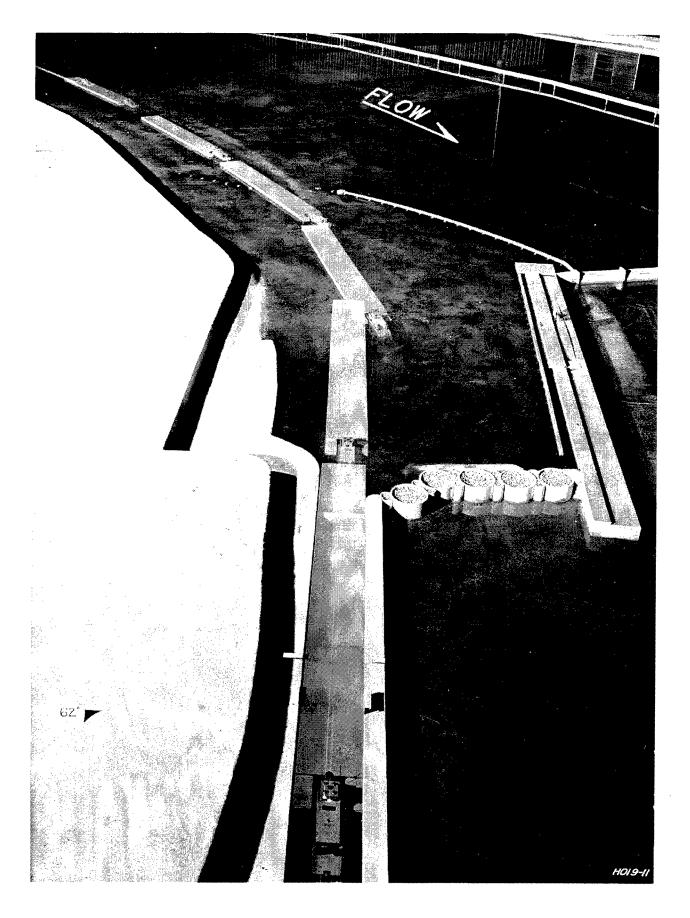
Photo 7. Base Test, total riverflow = 62,000 cfs, powerhouse discharge = 62,000 cfs. Looking upstream, showing the path of upbound leaving lock

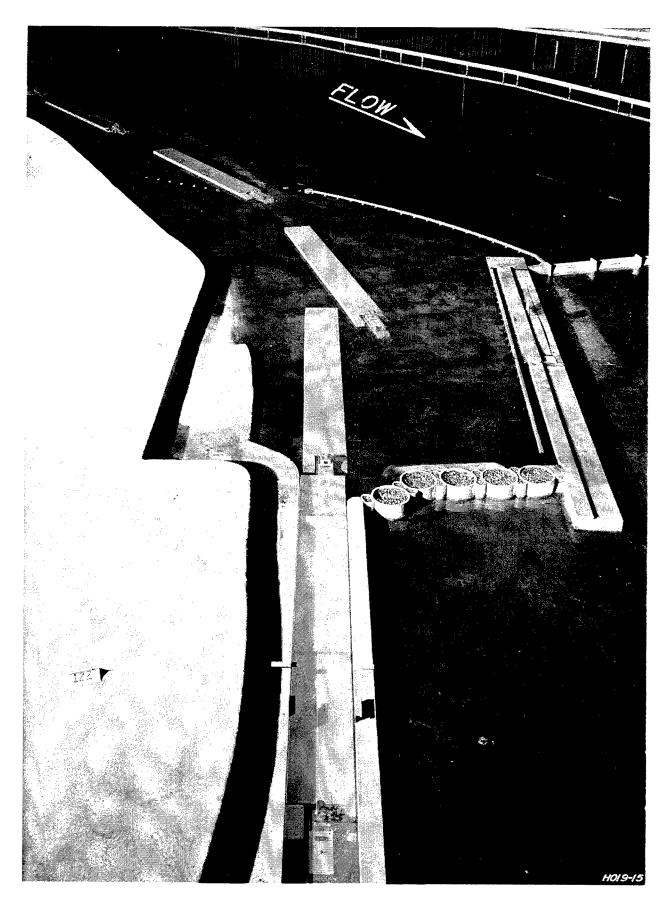
Photo 8. Base Test, total riverflow = 122,000 cfs, powerhouse discharge = 62,000 cfs. Looking upstream, showing the path of upbound tow leaving lock

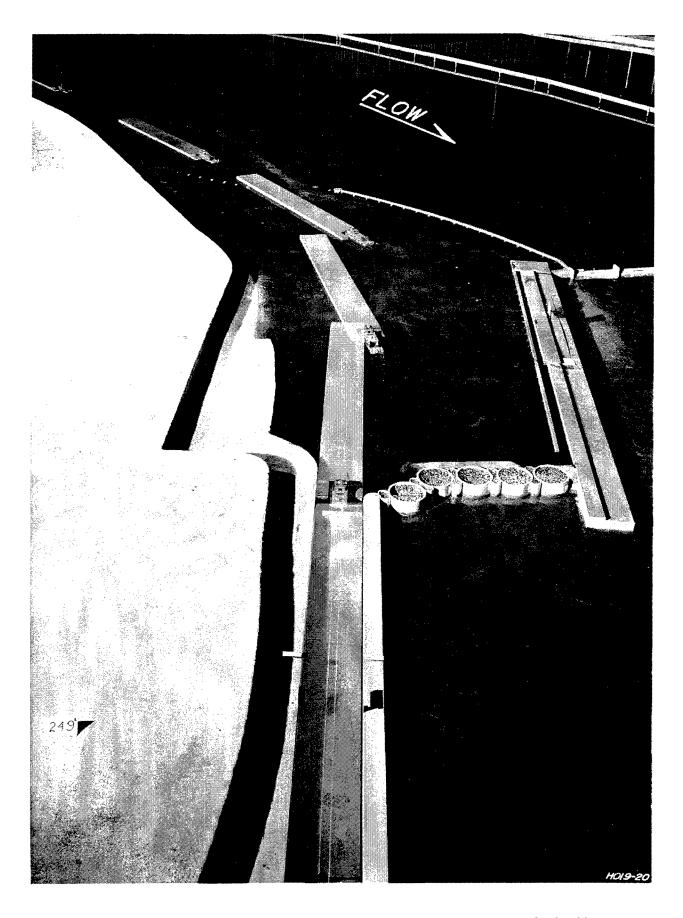
Photo 9. Base Test, total riverflow = 249,000 cfs, powerhouse discharge = 62,000 cfs. Looking upstream, showing the path of upbound tow leaving lock

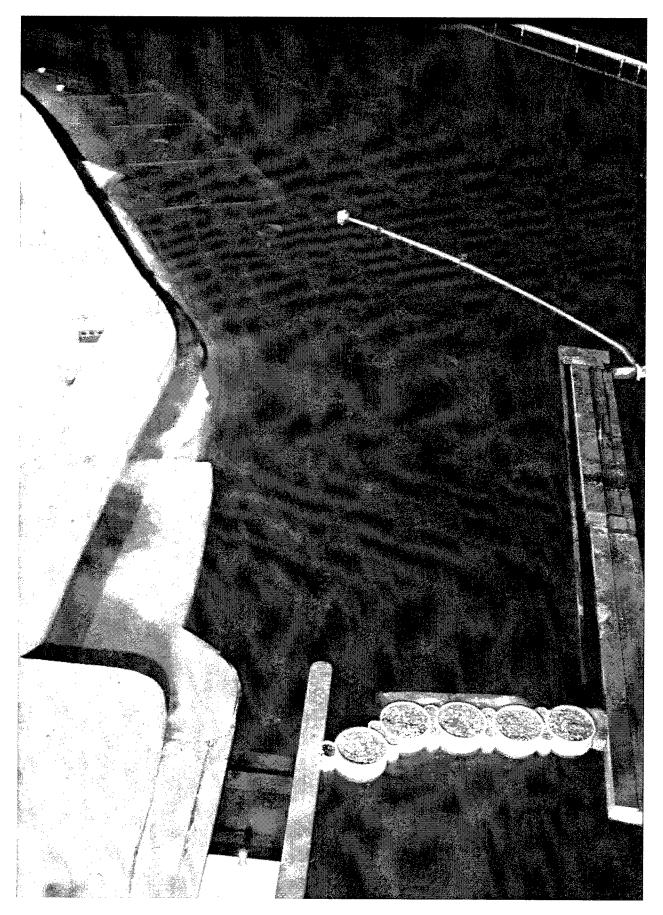
Photo 10. Plan D-1, looking upstream, showing the structures

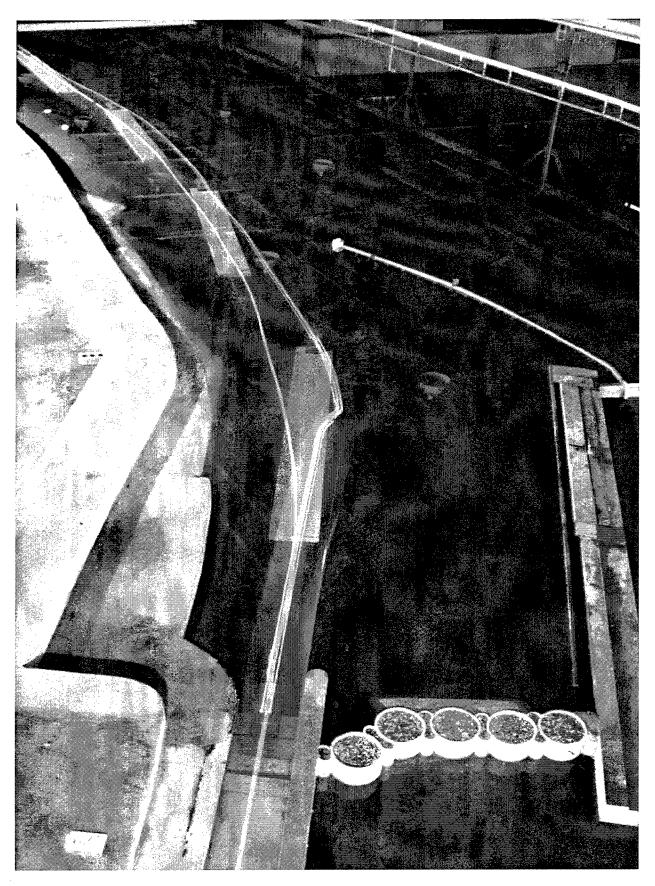
Photo 11. Plan D-1, total riverflow = 62,000 cfs, powerhouse discharge = 62,000 cfs. Looking upstream, showing the path of downbound tow approaching and entering the lock (note tendency for stern of tow to move toward powerhouse)

**Navigation conditions.** Navigation conditions for downbound tows entering the upper lock approach, shown in Plates 107-110 and Photos 11-13, did not significantly change when compared to the base test with existing conditions or Plan D. Downbound tows were required to approach the lock close to the right bank in the same manner as with the base test and Plan D. There was a tendency for the currents generated by the powerhouse to move the tow out of alignment with the lock and more maneuvering was required when downbound tows did not approach the lock close to the right bank (Plate 108 and Photos 11-12). The dike field redistributed the flow in the approach and the velocities along the right bank were increased. This could adversely impact a downbound tow approaching the lock, especially with the higher riverflows (Plate 110 and Photo 13). This is particularly important when making the final turning maneuver to align with and enter the lock chamber (Plates 108-110 and Photos 11-13). Navigation conditions for upbound tows, shown in Plates 111-113 and Photos 14-16, were nearly the same as the base test and Plan D. Upbound tows could push out of the lock chamber, clear the extension, and swing the head of the tow toward the right bank without major difficulties. With the higher riverflows, upbound tows exiting the upper lock approach may tend to encroach on the powerhouse more than in tests with existing conditions or tests with Plan D conditions (Plate 113 and Photo 16).

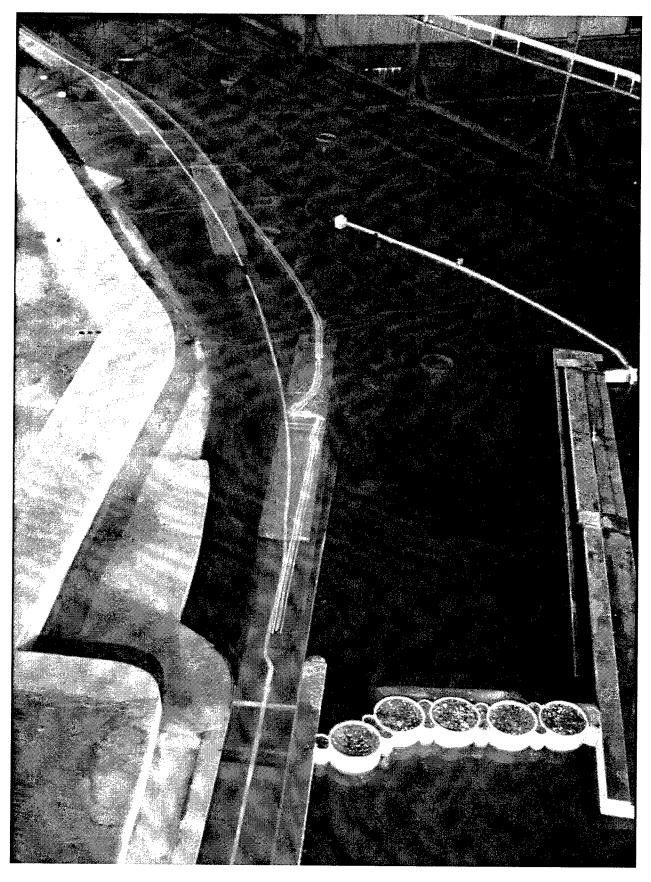
Photo 12. Plan D-1, total riverflow = 122,000 cfs, powerhouse discharge = 62,000 cfs. Looking upstream, showing the path of downbound tow approaching and entering the lock (note maneuvering required for tow to enter lock)

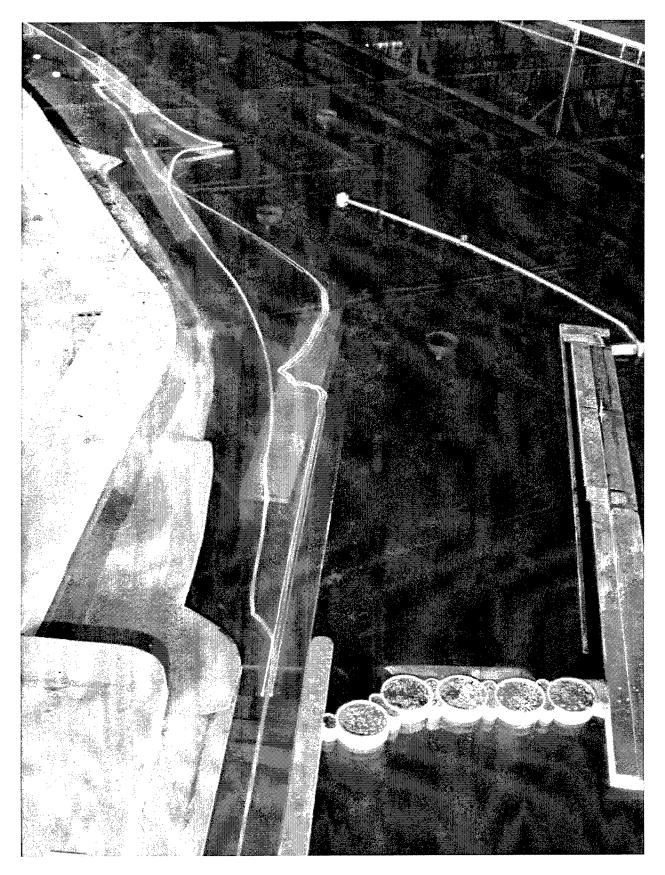
Photo 13. Plan D-1, total riverflow = 249,000 cfs, powerhouse discharge = 62,000 cfs. Looking upstream, showing the path of downbound tow approaching and entering the lock (note tendency for stern of tow to move toward powerhouse and maneuvering required to enter lock)

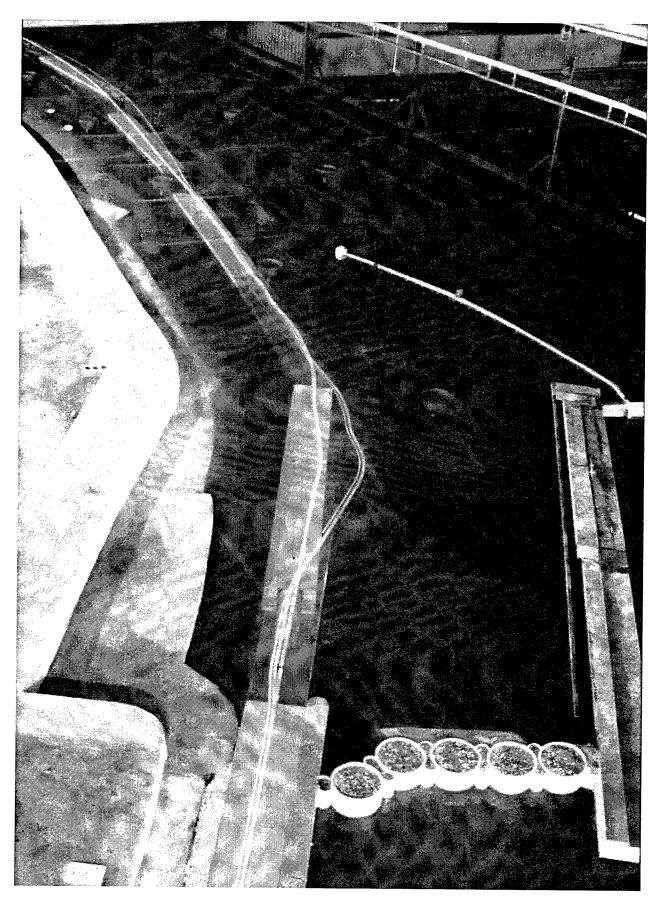
Photo 14. Plan D-1, total riverflow = 62,000 cfs, powerhouse discharge = 62,000 cfs. Looking upstream, showing the path of upbound tow leaving lock

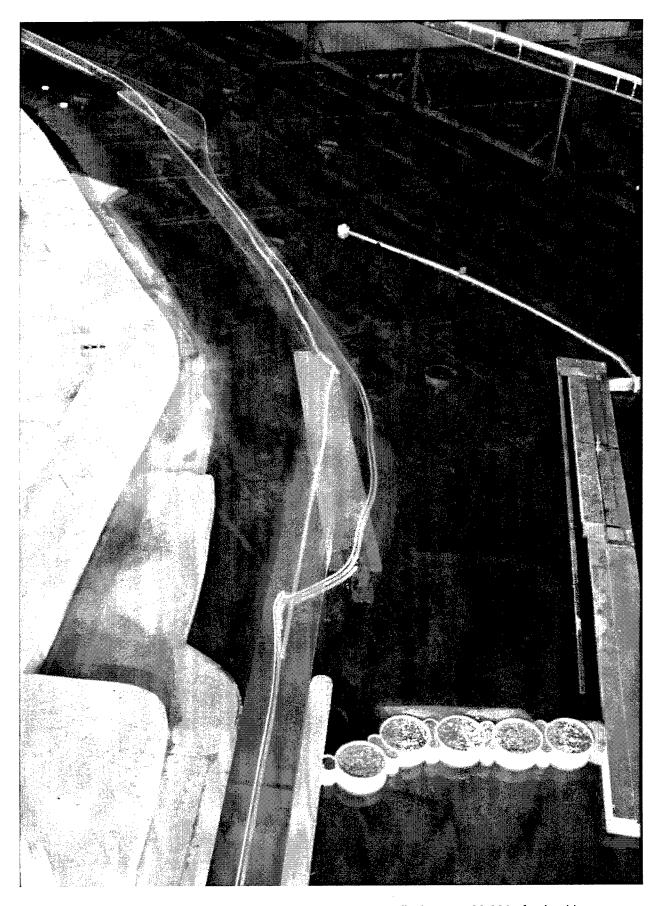
Photo 15. Plan D-1, total riverflow = 122,000 cfs, powerhouse discharge = 62,000 cfs. Looking upstream, showing the path of upbound tow leaving lock

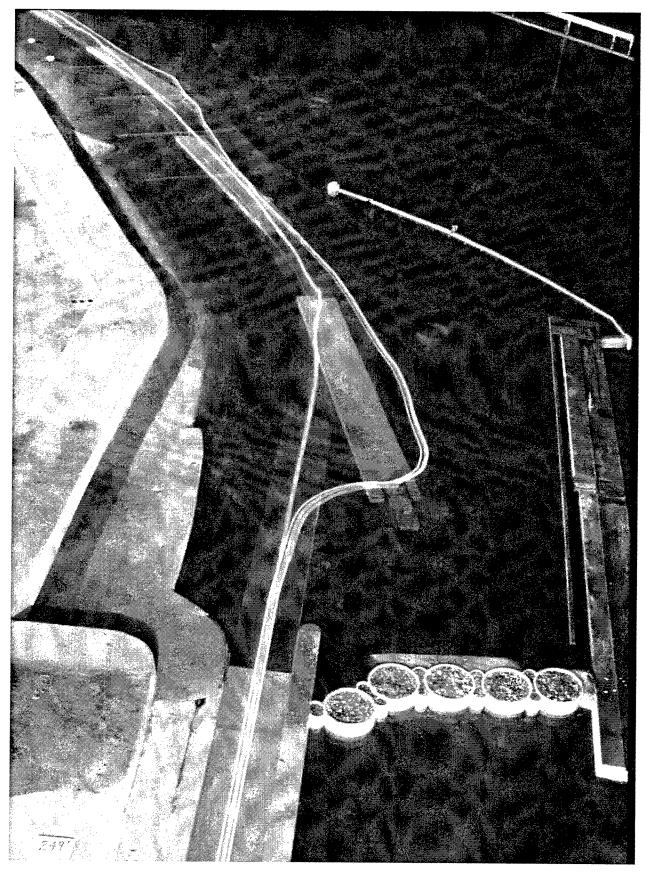
Photo 16. Plan D-1, total riverflow = 249,000 cfs, powerhouse discharge = 62,000 cfs. Looking upstream, showing the path of upbound tow leaving lock (note clearance between stern of tow and powerhouse)

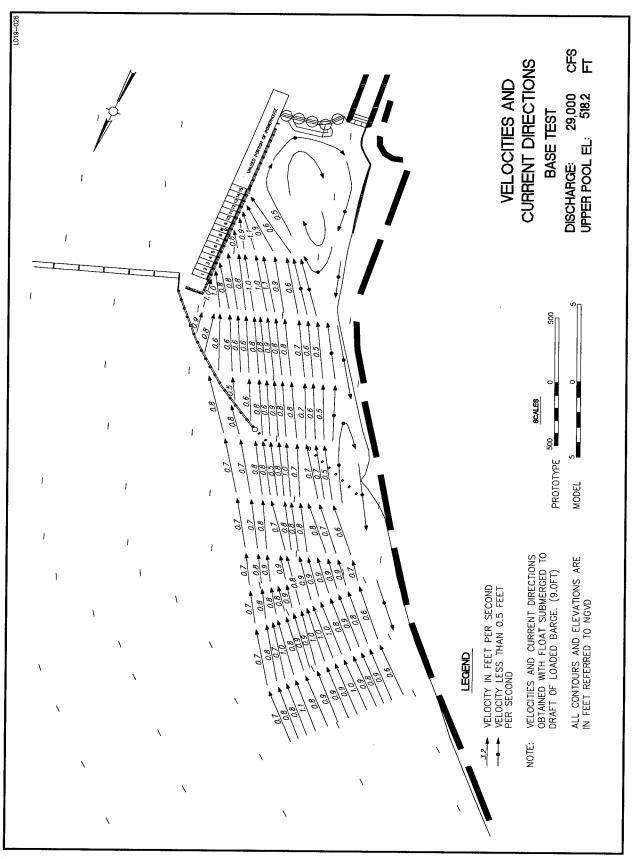
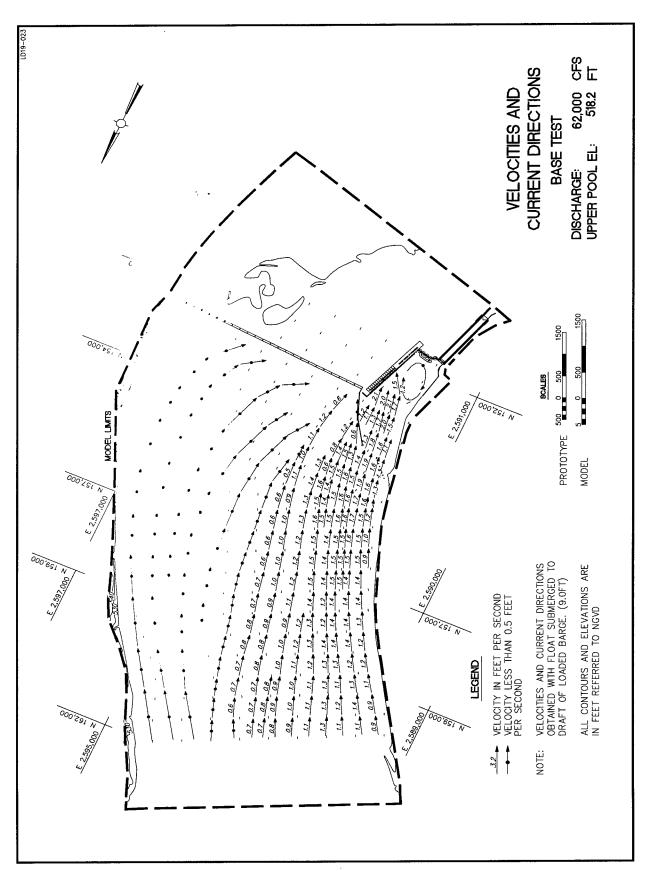
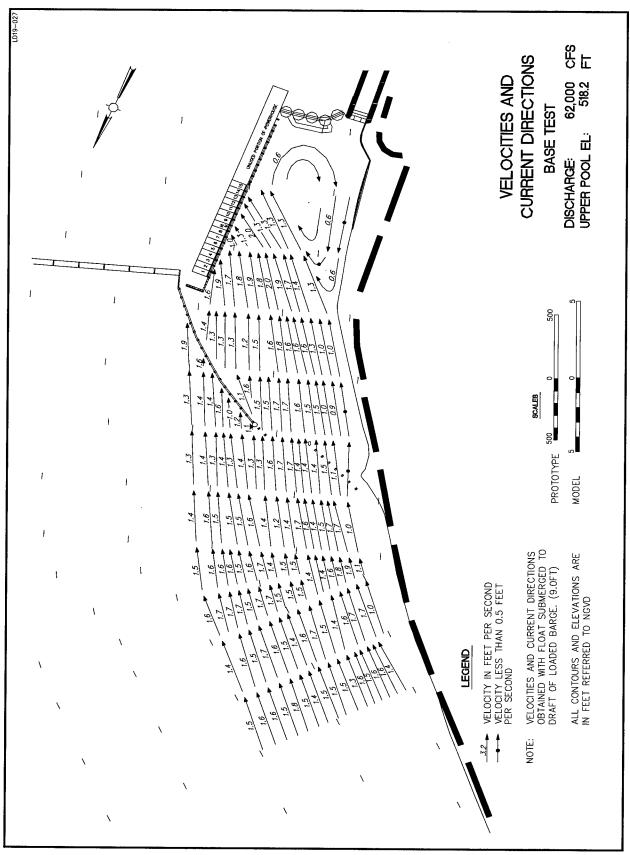
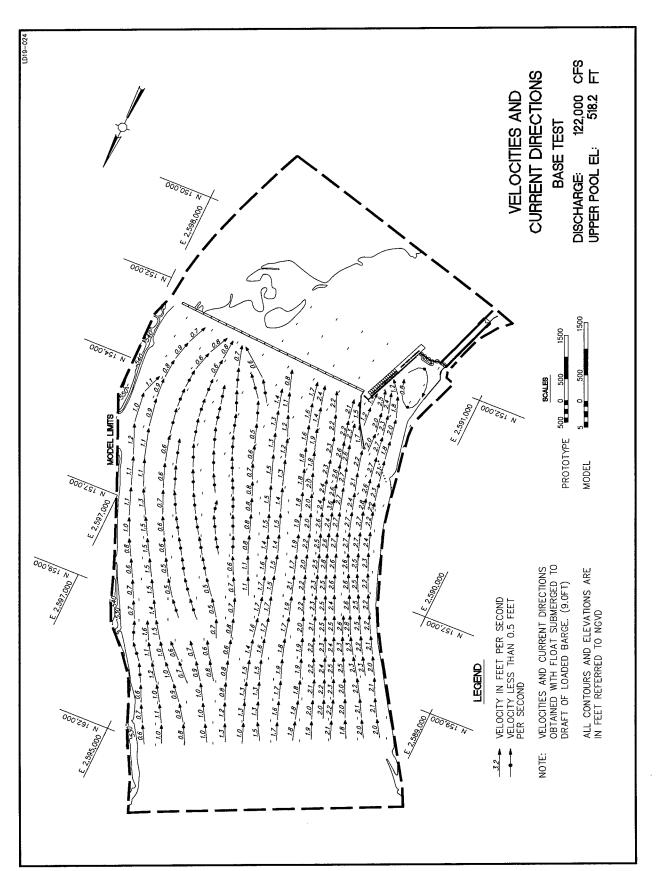
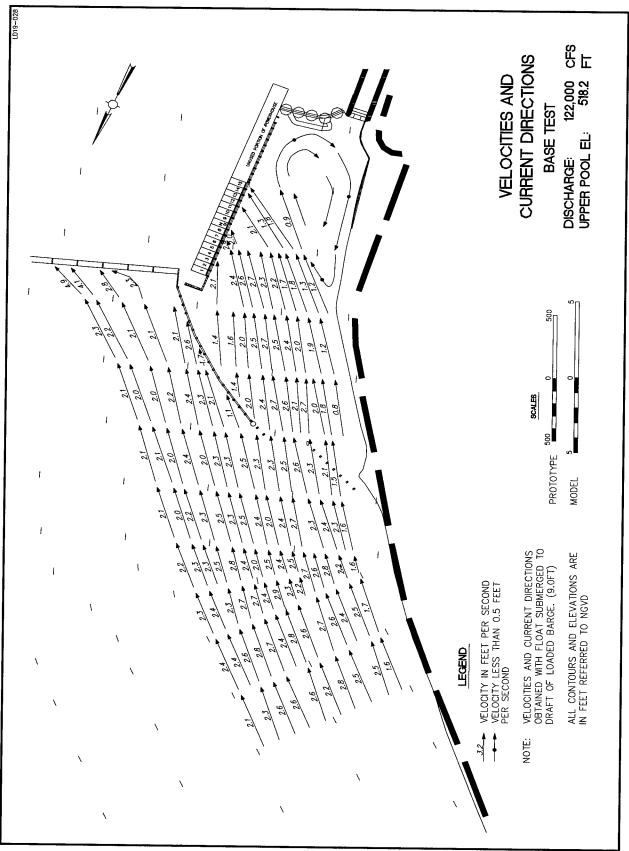
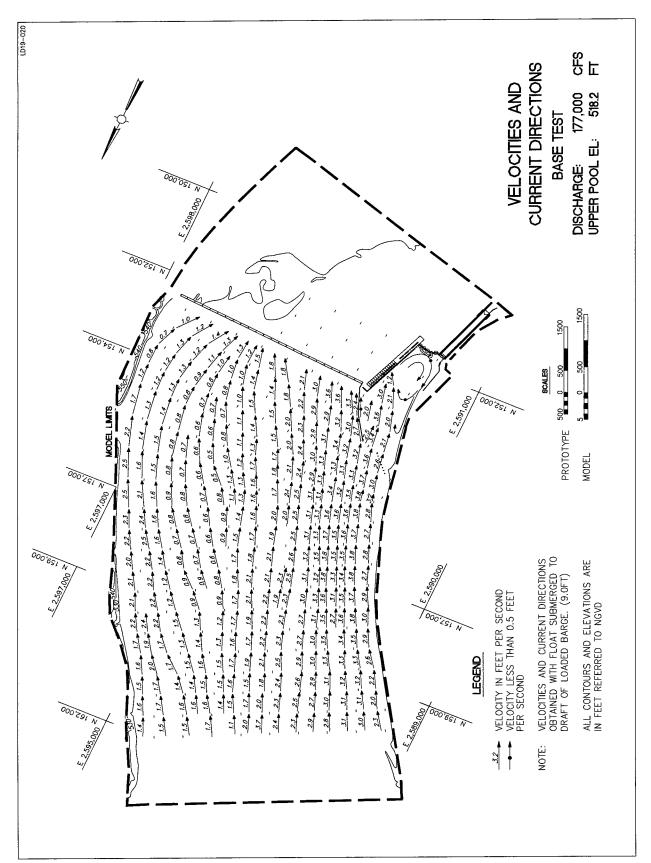
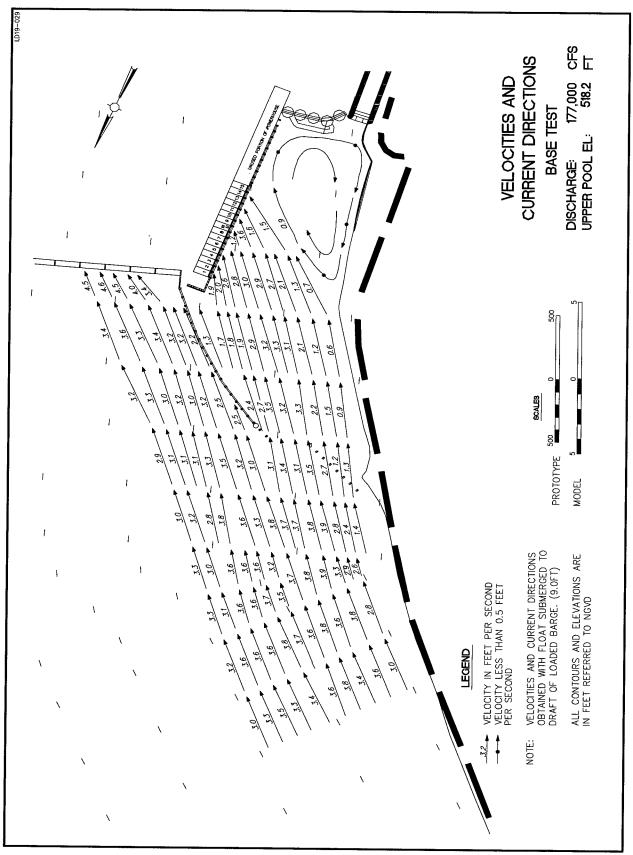
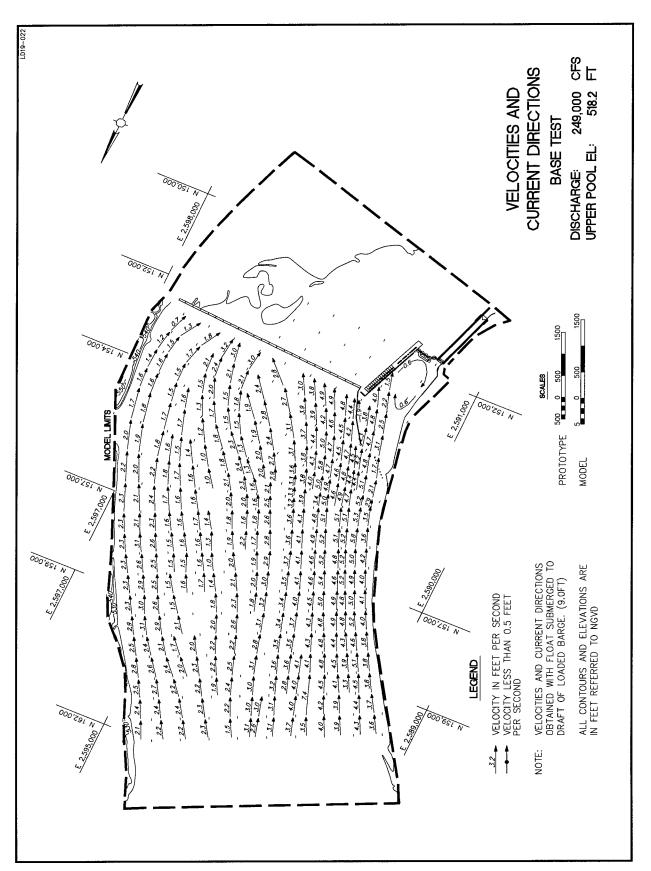
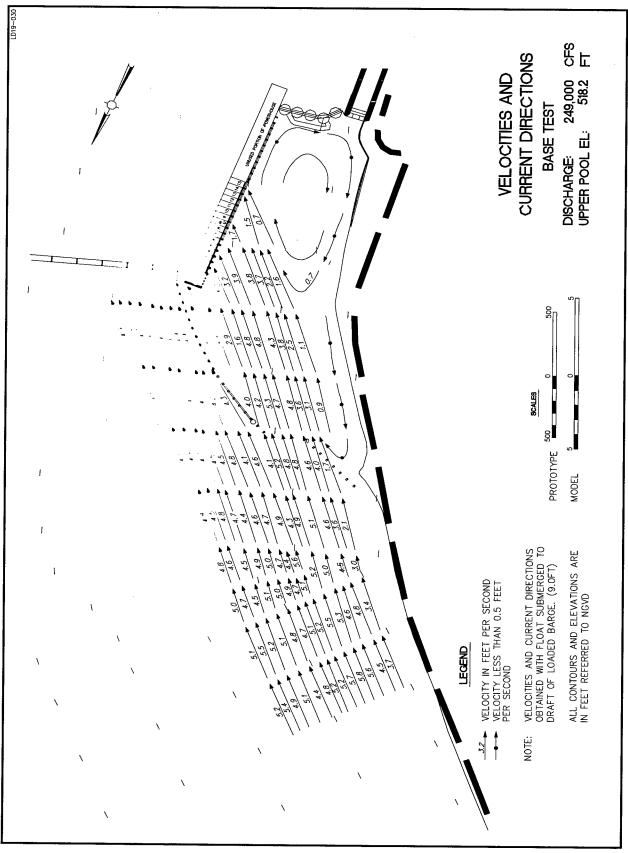
Current directions and velocities. Current direction and velocity data, as shown in Plates 1-10, indicated that the maximum velocity of the currents between the end of the radial ice fender and the right bank ranged in magnitude from 1.0 fps with a 29,000-cfs riverflow to 5.3 fps with a 249,000-cfs riverflow. The maximum velocity of the currents recorded in the forebays of the powerhouse and the lock ranged in magnitude from 1.1 to 4.8 fps with 29,000 and 249,000-cfs riverflows, respectively. A large clockwise eddy, as shown in Photo 2, formed in the upper lock forebay with all flows tested. The maximum upstream velocity of the upstream currents ranged from less than 0.5 to 0.7 fps.

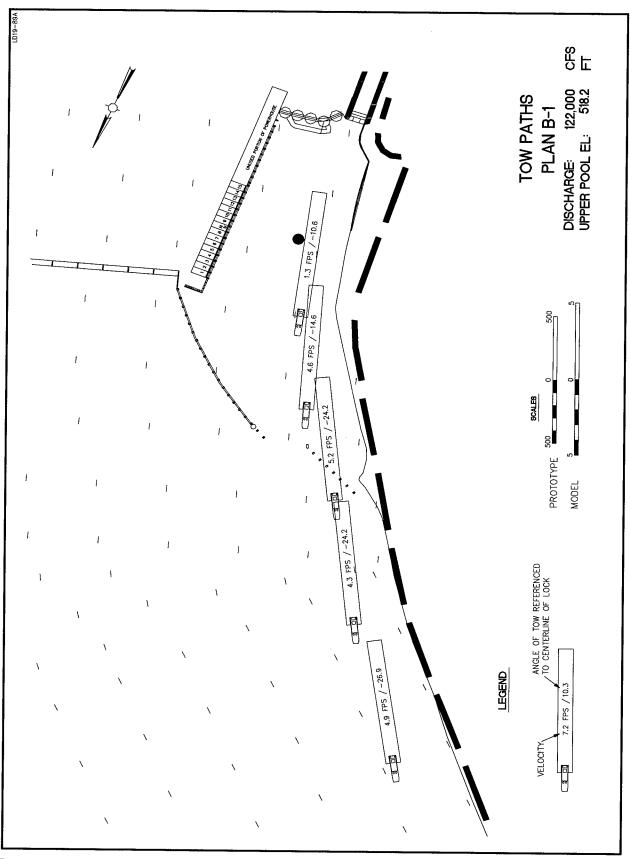
Plate 61

Navigation conditions. Navigation conditions for downbound tows were slightly improved when compared to Plan B (Plates 61-63). Properly aligned downbound tows approaching close along the right bank could enter the lock forebay and use the pivot cell to align with the lock chamber (Plate 61). Downbound tows entering the lock forebay misaligned with the lock could land on the pivot cell, but could be rotated around the cell if the stern is exposed to the currents moving toward the powerhouse, especially with the higher riverflows (Plate 62). There was a strong tendency for downbound tows entering the lock forebay to move toward or into the pivot cell with the higher riverflows (Plate 63). The placement of the cell in the lock forebay restricted the maneuvering area for upbound tows far more than Plan B. Upbound tows could not swing the stern of the tow until it cleared the cell; therefore, there was a strong tendency for the tow to be moved into the radial ice fender (Plates 64-66). As the riverflow increased, the danger of an upbound tow rotating around the pivot cell or moving into the radial ice fender increased.

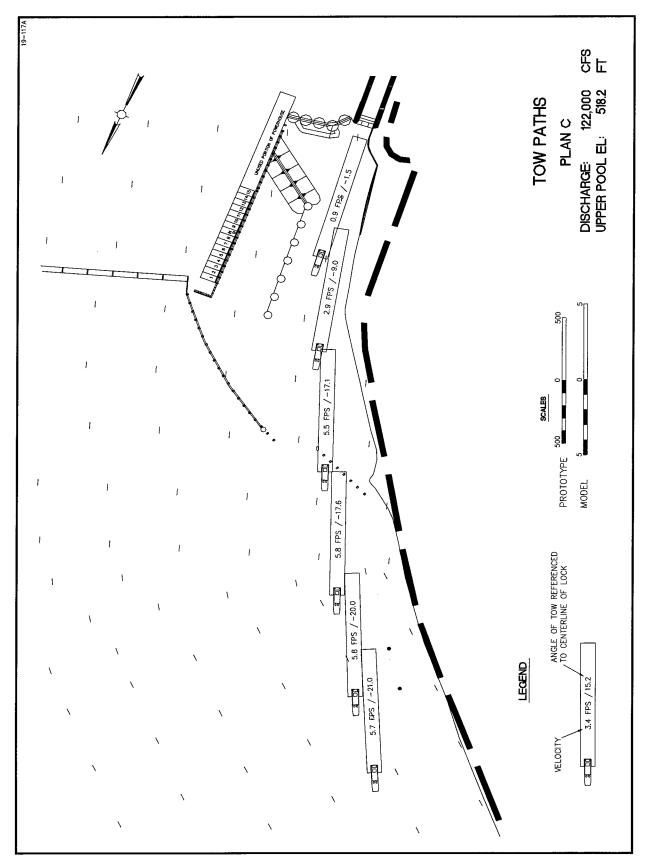
Plate 76

Navigation conditions. Navigation conditions were satisfactory for tows entering and exiting the upper lock approach with all riverflows tested (Plates 76-82). Although this plan did not provide a guide wall for downbound tows, tows would maneuver in slack water to align with the lock. With riverflows through 122,000 cfs, downbound tows could drive into the protection of the closure wall, reverse engines when the head of the tow was about 1,500 ft upstream of the lock, and align with the lock chamber without major difficulties. Downbound tows driving close along the right bank could approach the lock at a slower speed (Plate 77). With a 249,000-cfs riverflow, a flanking maneuver was required for downbound tows to maintain an acceptable speed entering the lock forebay. Downbound tows that were not properly aligned when entering the lock forebay exposed the stern of the tow to the outdraft near the upstream end of the closure wall and could be rotated out of alignment (Plate 78). Downbound tows moving close along the right bank and maintaining proper alignment entering the lock forebay could reverse engines about 1,200 ft upstream of the lock and align with the lock chamber without major difficulties, as shown in Plate 79. Navigation conditions were satisfactory for upbound tows. Upbound tows could push out of the lock chamber into the slack water canal, let the stern of the tow clear the lock, rotate the head of the tow toward the right bank and push out of the lock canal into the river channel, as shown in Plates 80-82. However, tows exiting the slack water canal parallel with the closure wall experienced a strong tendency to be pushed into the closure wall or the ice fender.

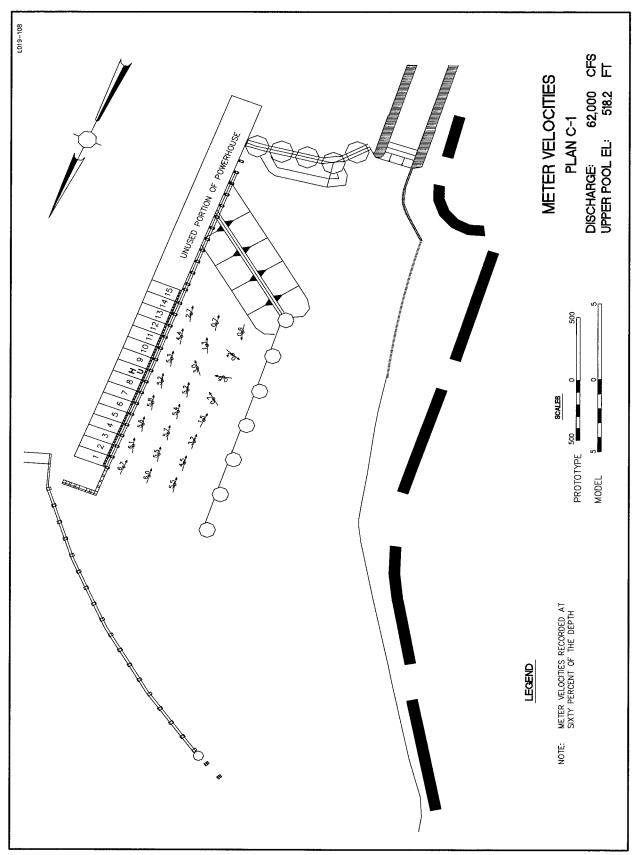
Plate 88

**Point velocities.** Meter velocity data (Plates 88 and 89) indicated a slight change in velocities in the powerhouse forebay and a change in the direction of the current approaching the powerhouse. The current was almost parallel to the powerhouse face. The maximum velocity recorded was 6.7 fps with a 249,000-cfs riverflow compared to 7.1 fps for Plan C.

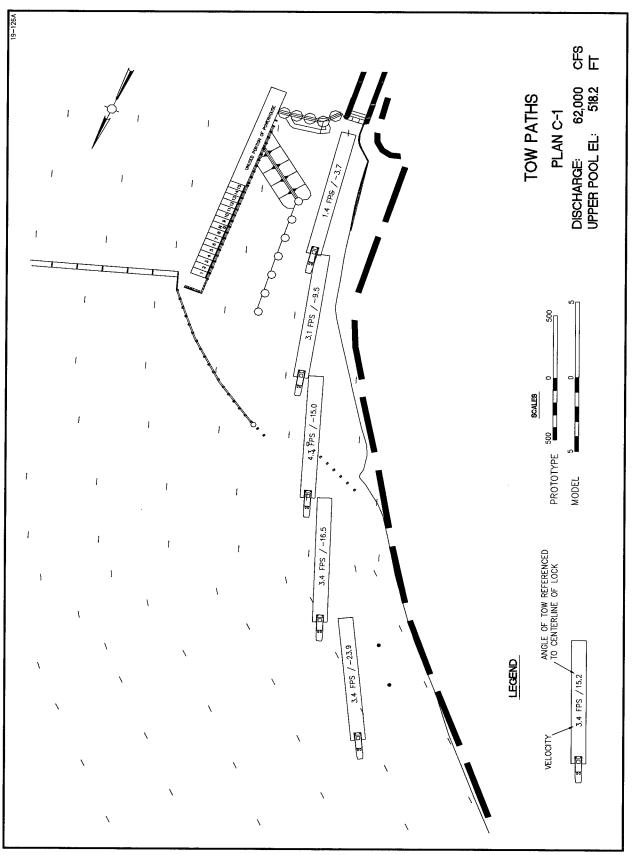
Plate 90

**Navigation conditions.** Navigation conditions were improved for tows entering and exiting the lock forebay with all riverflows tested (Plates 90 - 95). Downbound tows could enter the lock forebay with less speed and maneuvering due to the decrease in outdraft and current velocities when compared with Plan C. With riverflows through 122,000 cfs, downbound tows could drive into the protection of the closure wall, reverse engines when the head of the tow was about 1,500 ft upstream of the lock, and align with the lock chamber without major difficulties. With a 249,000-cfs riverflow, downbound tows could flank along the right bank to a point about 500 ft upstream of the ice fender, align the head of the tow with the right bank, and drive into the protection of the closure wall (Plate 92). Upbound tows could push out of the lock chamber into the slack water canal, let the stern of the tow clear the lock, rotate the head of the tow toward the right bank and push out of the lock canal into the river channel without major difficulties (Plates 93-95). However, tows exiting the slack water canal parallel with the closure wall experienced a strong tendency to be pushed into the closure wall or the ice fender.

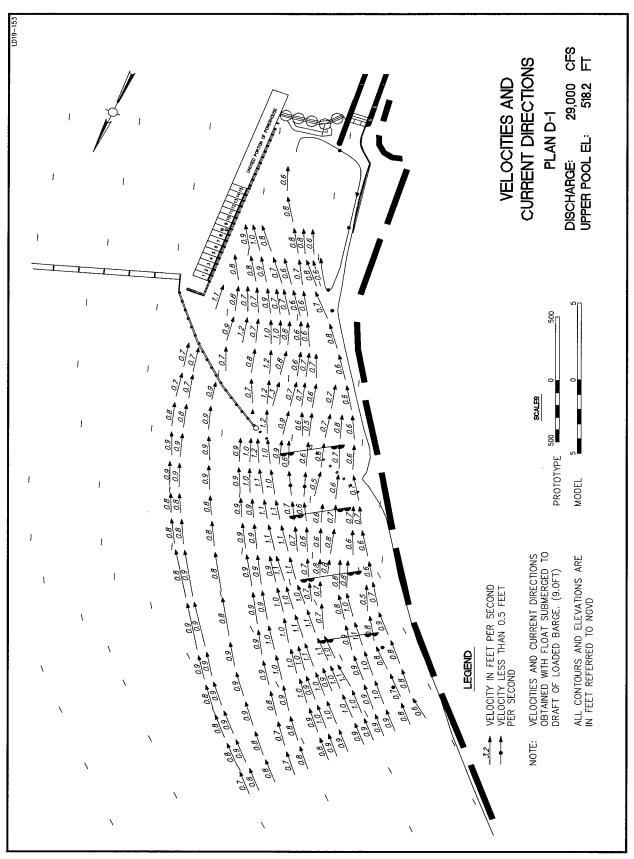
Plate 102

Current direction and velocities. Current direction and velocity data, shown in Plates 102 - 106, indicated a change in the current pattern and velocity in the upper lock approach when compared to the base tests; i.e., existing conditions. The dike field reduced current velocities near mid-channel in the upper lock approach; however, velocities increased along the right bank. The dike field redistributed the flow in the upper lock approach and reduced slightly the flow entering the approach. The current velocities near mid-channel at the upstream end of the ice fender were reduced about 0.4 and 2.0 fps with 62,000-and 249,000-cfs riverflows, respectively, when compared to the base test.
